THERMOGRAPHY- APPLICATION NOTE

Infrared Thermal Imaging-Principle

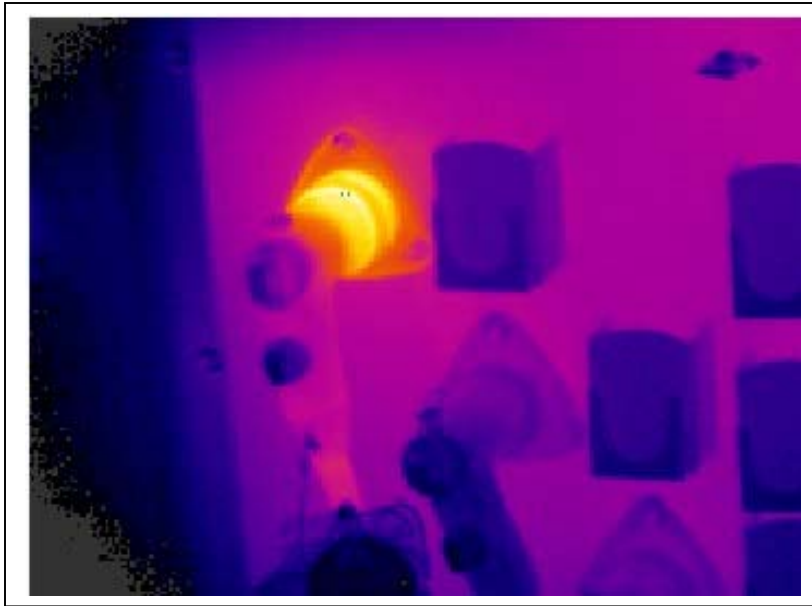
CASE 1

Equipment: Main cable termination inside power panel.

Detected unsafe condition: High temperature in R-phase cable lug & insulator.

Recommendations: Re-lug the R-core and re-terminate the cable. Replace the R-phase insulator also. After taking the above corrective measures, carry out T-imaging again and ensure that the hotspots do not exist.

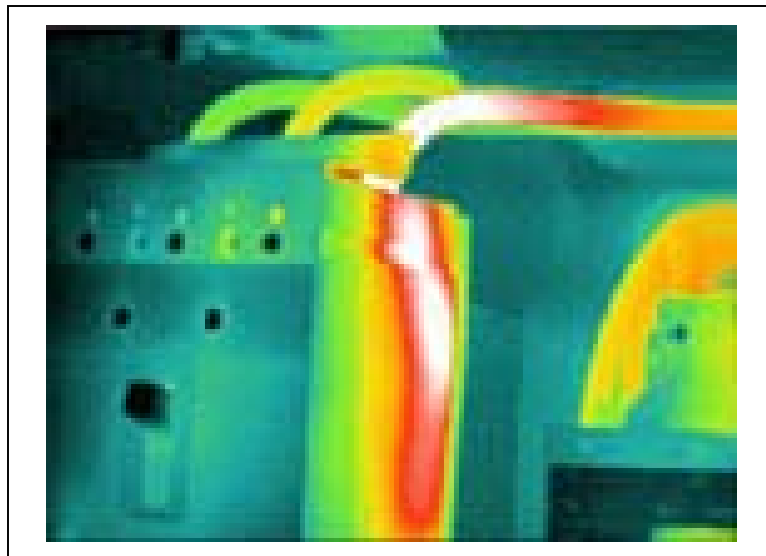
CASE 2

Equipment: Moulded Case Circuit Breaker (MCCB).

Detected unsafe condition: High temperature in B-phase terminal of MCCB, feeding emergency lighting loads.

Recommendations: Re-lug the cable B-core and re-terminate the cable properly. If the high temperature problem persists, then replace the R-phase terminal contacts. After taking the above corrective measures, carry out T-imaging again and ensure that the electrical hotspot do not exist.

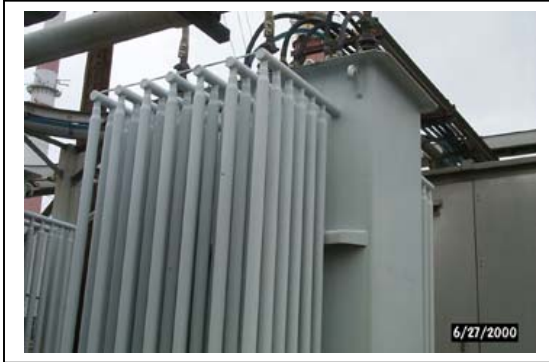
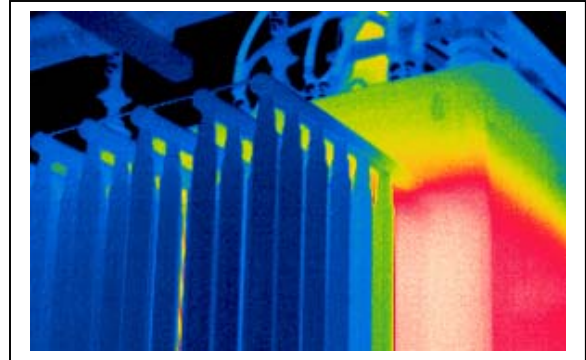
CASE 3

Transformer-Normal view

Transformer-T-image

Equipment: 1500 KVA outdoor transformer

Detected unsafe condition: High temperature indicating low oil level in transformer.

Recommendations: Investigate the problem of low oil level in transformer and take corrective action (Settings of OTI & WTI, arrest oil leak, interlock low oil level with an alarm, daily visual inspection).

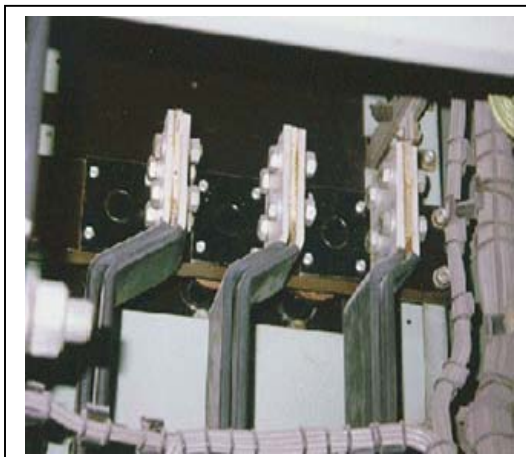
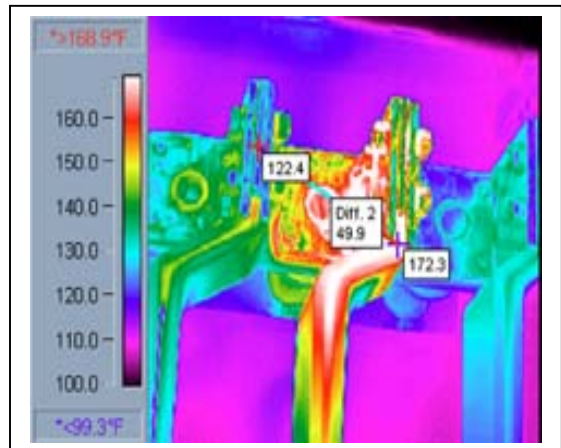
CASE 4

Busbar connection-Normal view

Busbar Connection-T-image

Equipment: Busbars inside main PCC, feeding critical loads.

Detected unsafe condition: High temperature in Y-Phase busbar connection indicating hotspot, probably due to improper / loose bolting.

Recommendations: Correct the improper busbar bolt connection.
